# Hypervelocity Impact Testing of IM7/977-3 with Micron-Sized Particles

J.G. Smith Jr.<sup>\*</sup>, D.C. Jegley<sup>†</sup>, and E.J. Siochi<sup>‡</sup>  
*NASA Langley Research Center, Hampton, VA 23681-2199*

**Ground-based hypervelocity impact testing was conducted on IM7/977-3 quasi-isotropic flat panels at normal incidence using micron-sized particles (i.e.  $\leq 100 \mu\text{m}$ ) of soda lime glass and olivine. Testing was performed at room temperature (RT) and 175°C with results from the 175°C test compared to those obtained at RT. Between 10 and 30 particles with velocities ranging from 5 to 13 km/s impacted each panel surface for each test temperature. Panels were ultrasonically scanned prior to and after impact testing to assess internal damage. Post-impact analysis included microscopic examination of the surface, determination of particle speed and location, and photomicroscopy for microcrack assessment. Internal damage was observed by ultrasonic inspection on panels impacted at 175°C, whereas damage for the RT impacted panels was confined to surface divets/craters as determined by microscopic analysis.**

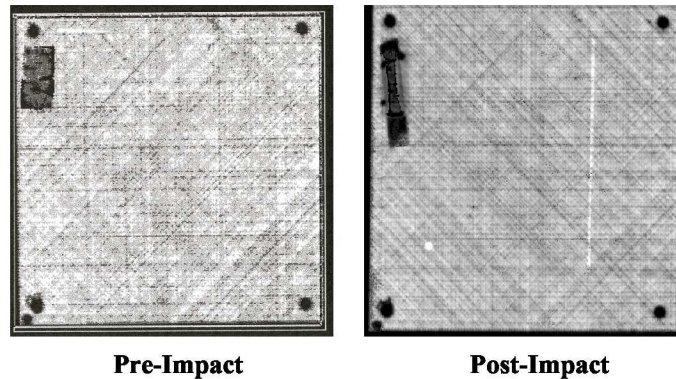
Figure 5. C-scan of pre- and post-impact RT SLG test panel.

In order to establish a baseline, an impact test was performed at RT. Prior to testing, the panel was determined by Ultrasonic inspection to be well consolidated (Fig. 5). After HVI testing, gross visual analysis suggested no detectable damage. The post-impact panel C-scan image was found to exhibit no detectable difference (i.e. damage) compared to the pre-impact panel image (Fig. 5). The white vertical line observed in the post-impact image was due to a support bar in the water tank. Image analysis of the post impact panel under magnification revealed surface damage in the form of divets or craters with depths that were several times the crater diameter.

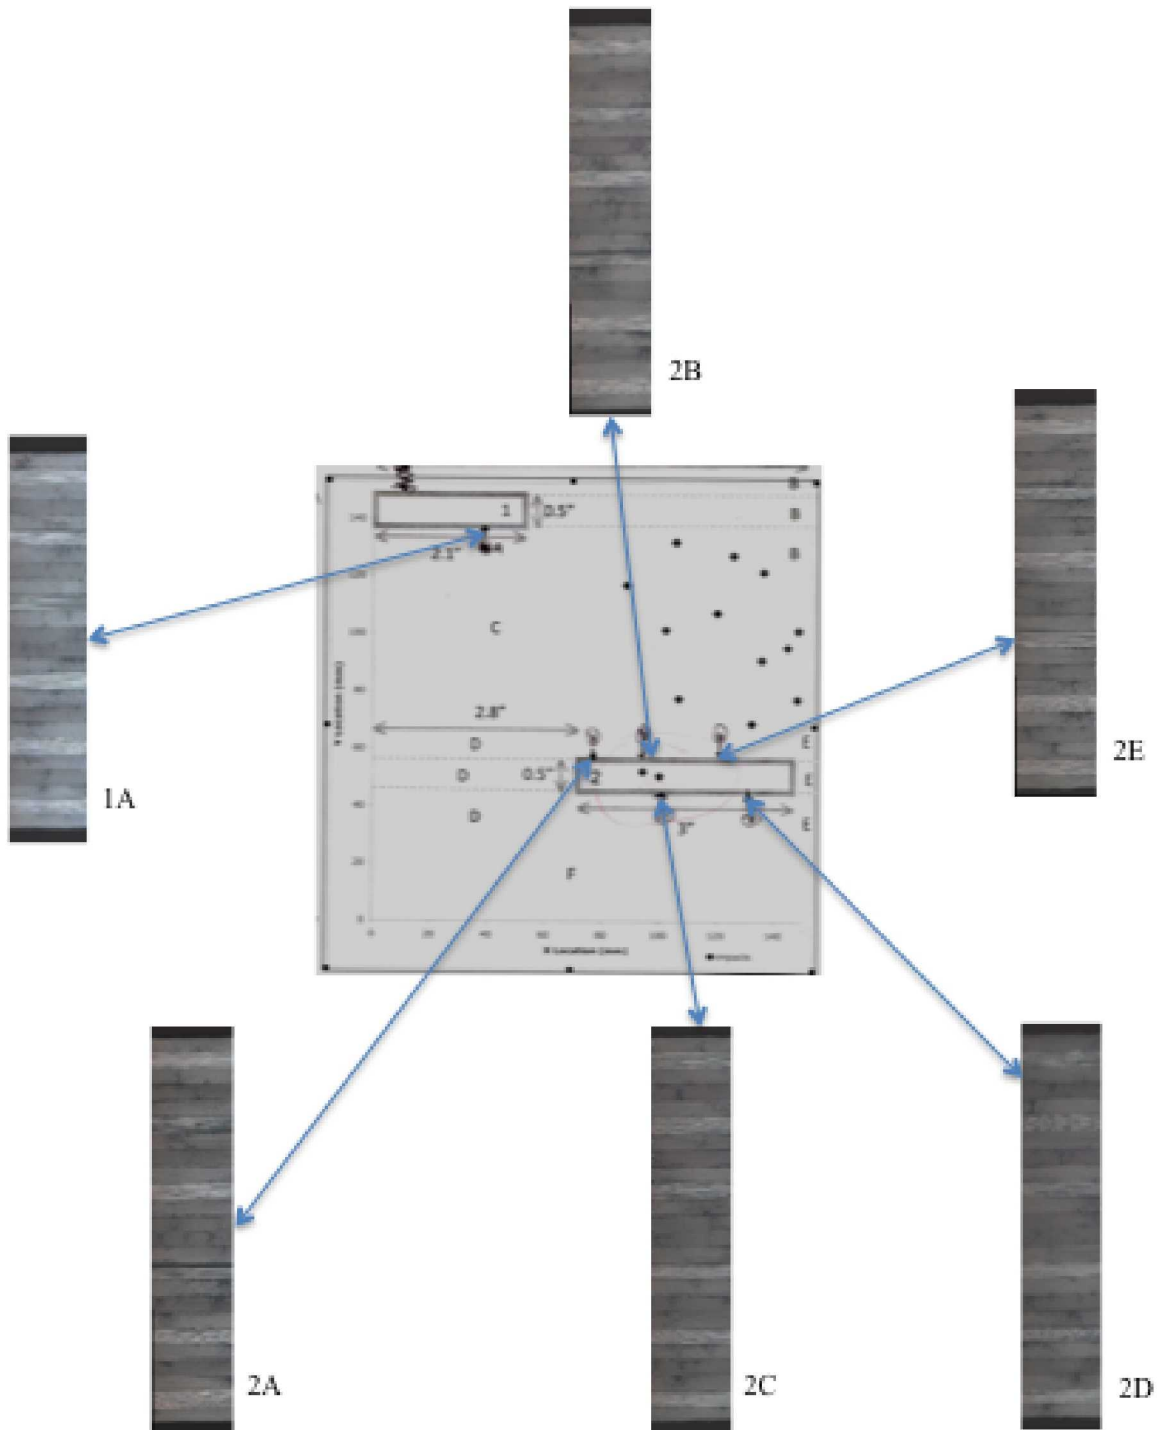
**Figure 7. Photomicrograph map of RT SLG FRPC test panel.**

To further assess the effects of the SLG impacts at RT, two specimens were cut and polished from the FRPC. These sections included areas with and without impacts. Photomicrographs of these areas and their respective

location on the FRPC revealed no internal damage (i.e. delamination and microcracking) are shown in Fig. 7. This was further supported by the post-impact C-scan image shown in Fig. 5.

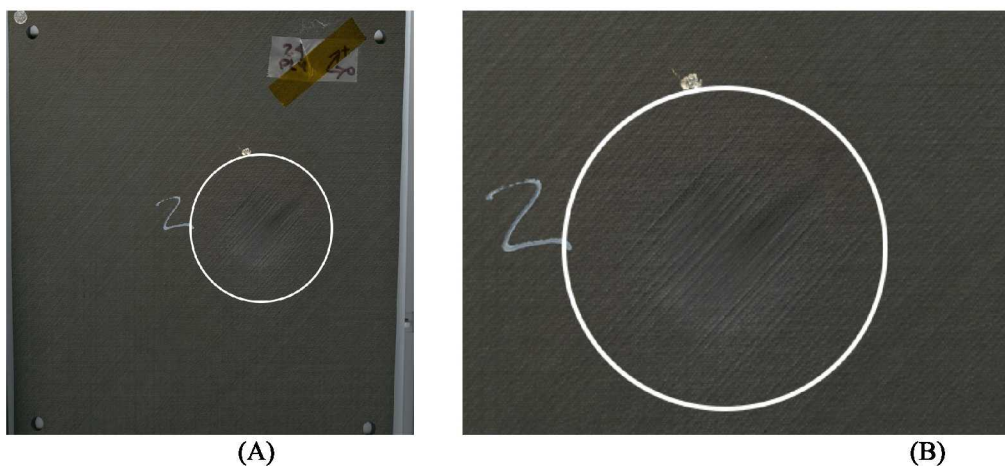
**Figure 9. A) Scanner image of depression on the post-impact elevated temperature SLG test panel and B) Close-up scan of depression.**

Despite the fact that the LEO and Lunar environments include both cryogenic and elevated temperatures, only a few reported studies have been conducted at these temperatures.<sup>16-18</sup> In this study ET HVI testing was performed at 175°C on a pristine panel. The test temperature was chosen based on the upper reported dry service temperature of 177°C for the FRPC.<sup>24</sup> Gross visual inspection of the post-impact panel revealed a depression (i.e. located within circle) in the impact area (Fig. 9) that was larger than expected given the size of the impactor (i.e. average particle diameter of 68 μm in Table 2). This observation was unexpected since heating the FRPC would not have caused such a depression to form. Image analysis of the post-impact panel under magnification revealed divets or craters in the top ply similar to those observed for the RT SLG post-impact panel as well as several parallel cracks in the impact area. These cracks were presumed to be from stress build-up in the FRPC during heating due to the tight fit of the mounting bolts used to secure the FRPC to the test stand.

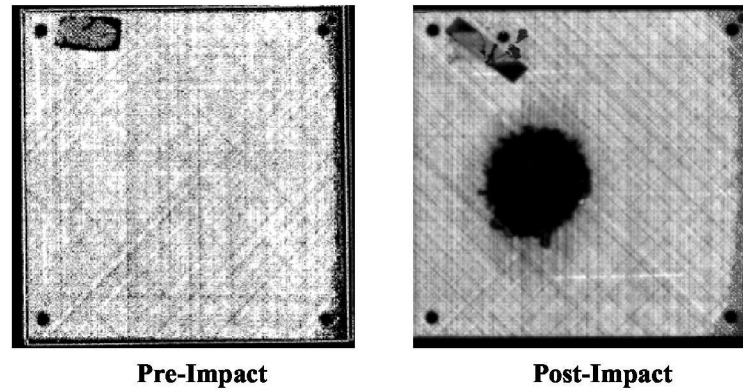
**Figure 10. C-scan of pre- and post- impact ET SLG test panel.**

Based on the visual analysis, the C-scan image of the post-impacted FRPC was of interest. The C-scan image of the post-impacted FRPC in Fig. 10 showed a large circular damage area compared to the pre-impact FRPC. This area was larger than that observed visually on the panel surface (Fig. 9) and was presumably due to delamination.

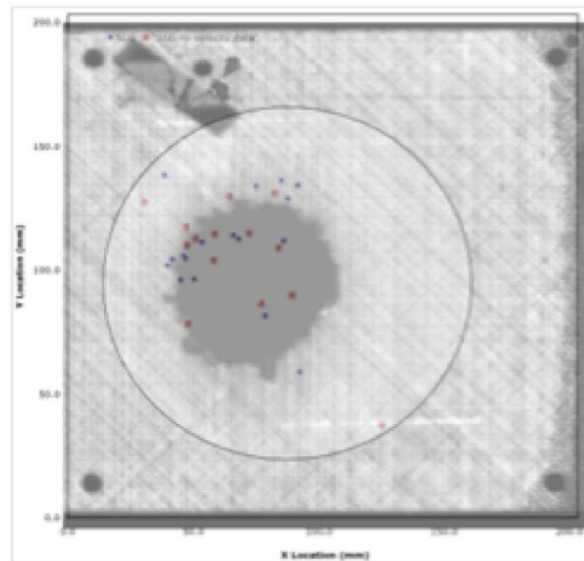
**Figure 12. Overlay of post-impact panel C-scan image over graphed SLG Impacts with known (blue) and unknown (red) velocities.**

An overlay of the graphed impact locations in Fig. 11 over the post-impact C-scan image in Fig. 10 was made to view the SLG impacts in relation to the damage area (Fig. 12). The circular image in the overlay in Fig. 12 is a representation of the impact area centered on the bore of the gun barrel. The locations of SLG impactors with known

and unknown velocities identified in blue and red, respectively, are shown in Fig. 12. As seen in Fig. 12, a majority of the SLG impactors resided in the damage area detected by Ultrasonic inspection. A few of the impactors resided outside this area with no perceivable damage other than that observed under magnification. Given the reduction of composite properties at elevated temperature,<sup>15</sup> it was speculated that the resultant damage may have been induced by the generated shock waves from each of the impacting particles through constructive and destructive addition. It has been reported that at elevated temperature the composite toughness of this system was higher, but a lower number of cycles were needed for delamination to occur and faster fatigue crack propagation was observed.<sup>16</sup> This theory may aid in the explanation of the result seen here even though the FRPC was not cycled in this study.

Another possible explanation for the damage observed in the post impact C-scan image is that it was caused solely by heat. The distance between the mounting of the silicon diodes and the heat lamps may have contributed to greater heating in the area in direct line of the illumination than was recorded by the data monitoring system. FRPCs are known to have low thermal conductance. Several diodes were mounted on the FRPC but the sensors were positioned away from the beam to minimize direct heating of the sensors. If the heating method did not achieve a uniform heating, then there may have been an overshoot in sample temperature. However a large damage area is not observed in Fig. 5 outside the impacted area. Therefore this explanation is not complete and requires further work to determine the exact cause of the observed delamination.

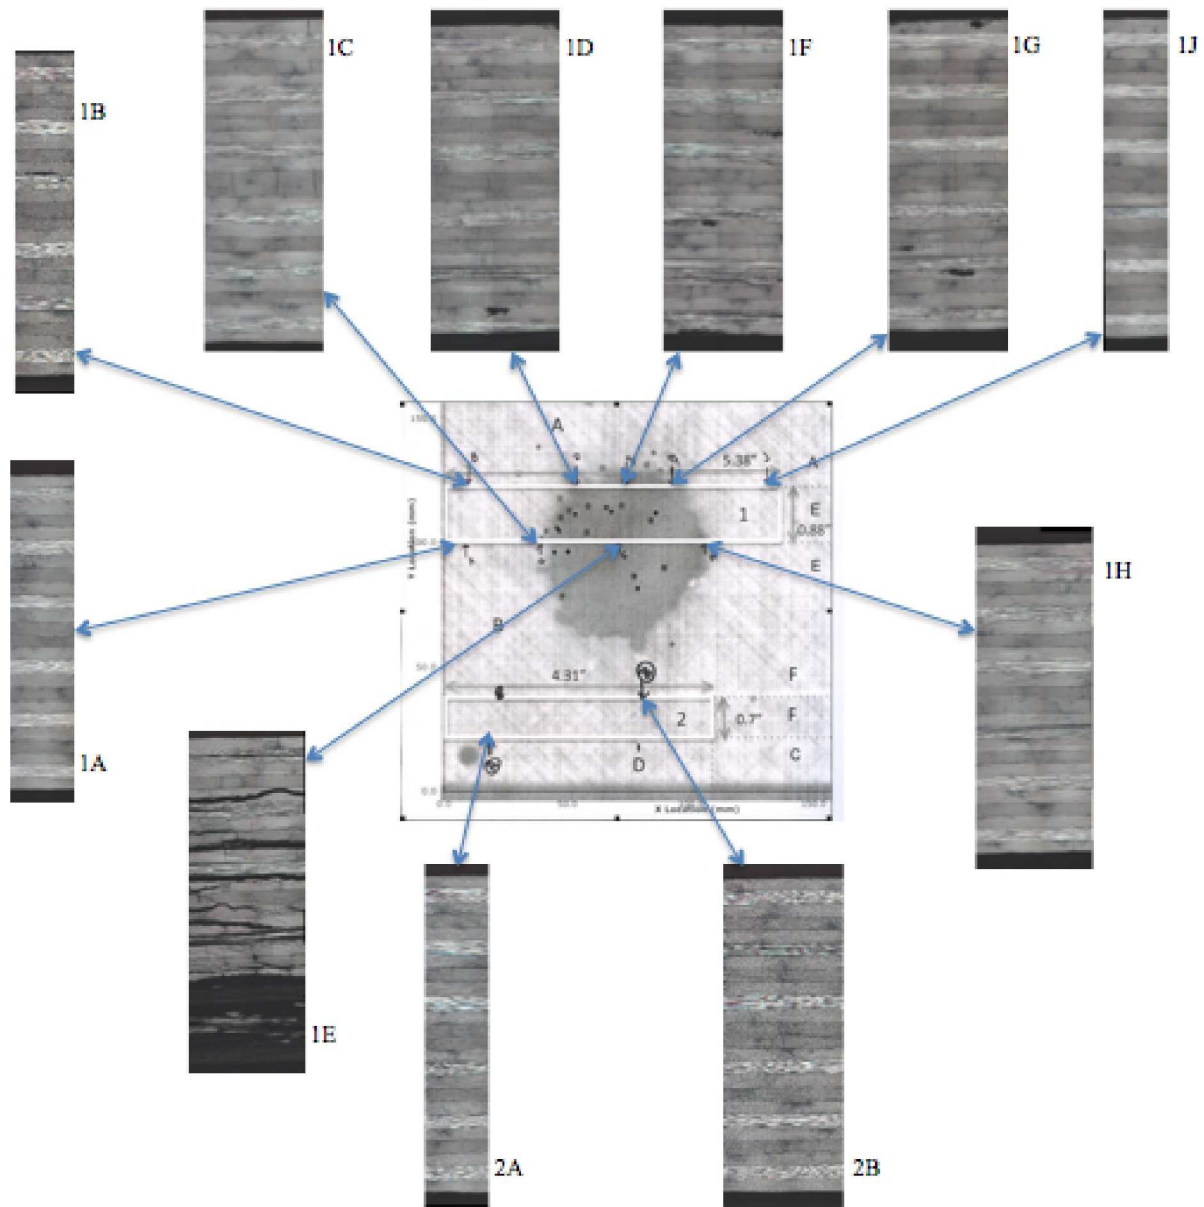
**Figure 13. Photomicrograph map of RT SLG FRPC test panel.**

To assess internal effects due to the SLG impactors, two sections were cut and polished from the post-impacted FRPC and photomicrographs obtained. These sections included areas with and without impacts as well as areas within and outside the damage area indicated by the C-scan image. The photomicrographs of these areas and the associated location on the FRPC are shown in Fig. 13. Photomicrographs 1A, 1B, 1J, 2A, and 2B were well consolidated with no evidence of damage. These areas were outside the damage area and devoid of impacts. The remaining photomicrographs revealed numerous microcracks. Photomicrographs 1E and 1F taken in areas within the damage zone also showed delamination as supported by the post-impact C-scan image. Heavy delamination was indicated in photomicrograph 1E.

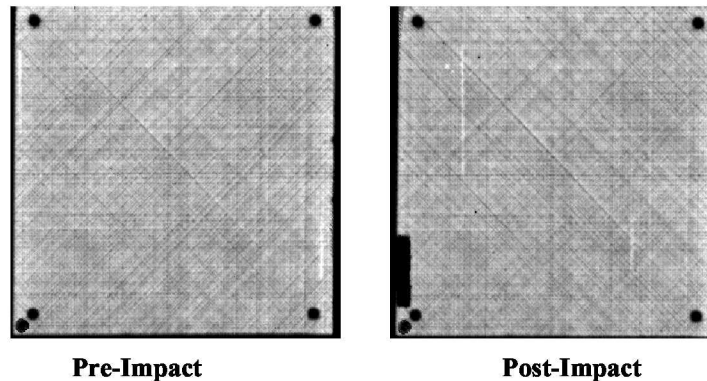
**Figure 15. C-scan of pre- and post-impact RT OLV panel.**

A HVI baseline test was performed at RT using OLV as the impactor. No difference was observed by comparison of the C-scan images of the pre- and post-impact FRPC implying that no internal delamination had occurred (Fig. 15). The white lines in the post-impact image were due to the support bars in the water tank. Post-impact microscopic analysis of the FRPC surface revealed that damage was primarily confined to the top ply in the form of divets/craters with depths that were several times the crater diameter. These results were comparable to those for SLG HVI testing performed at RT.

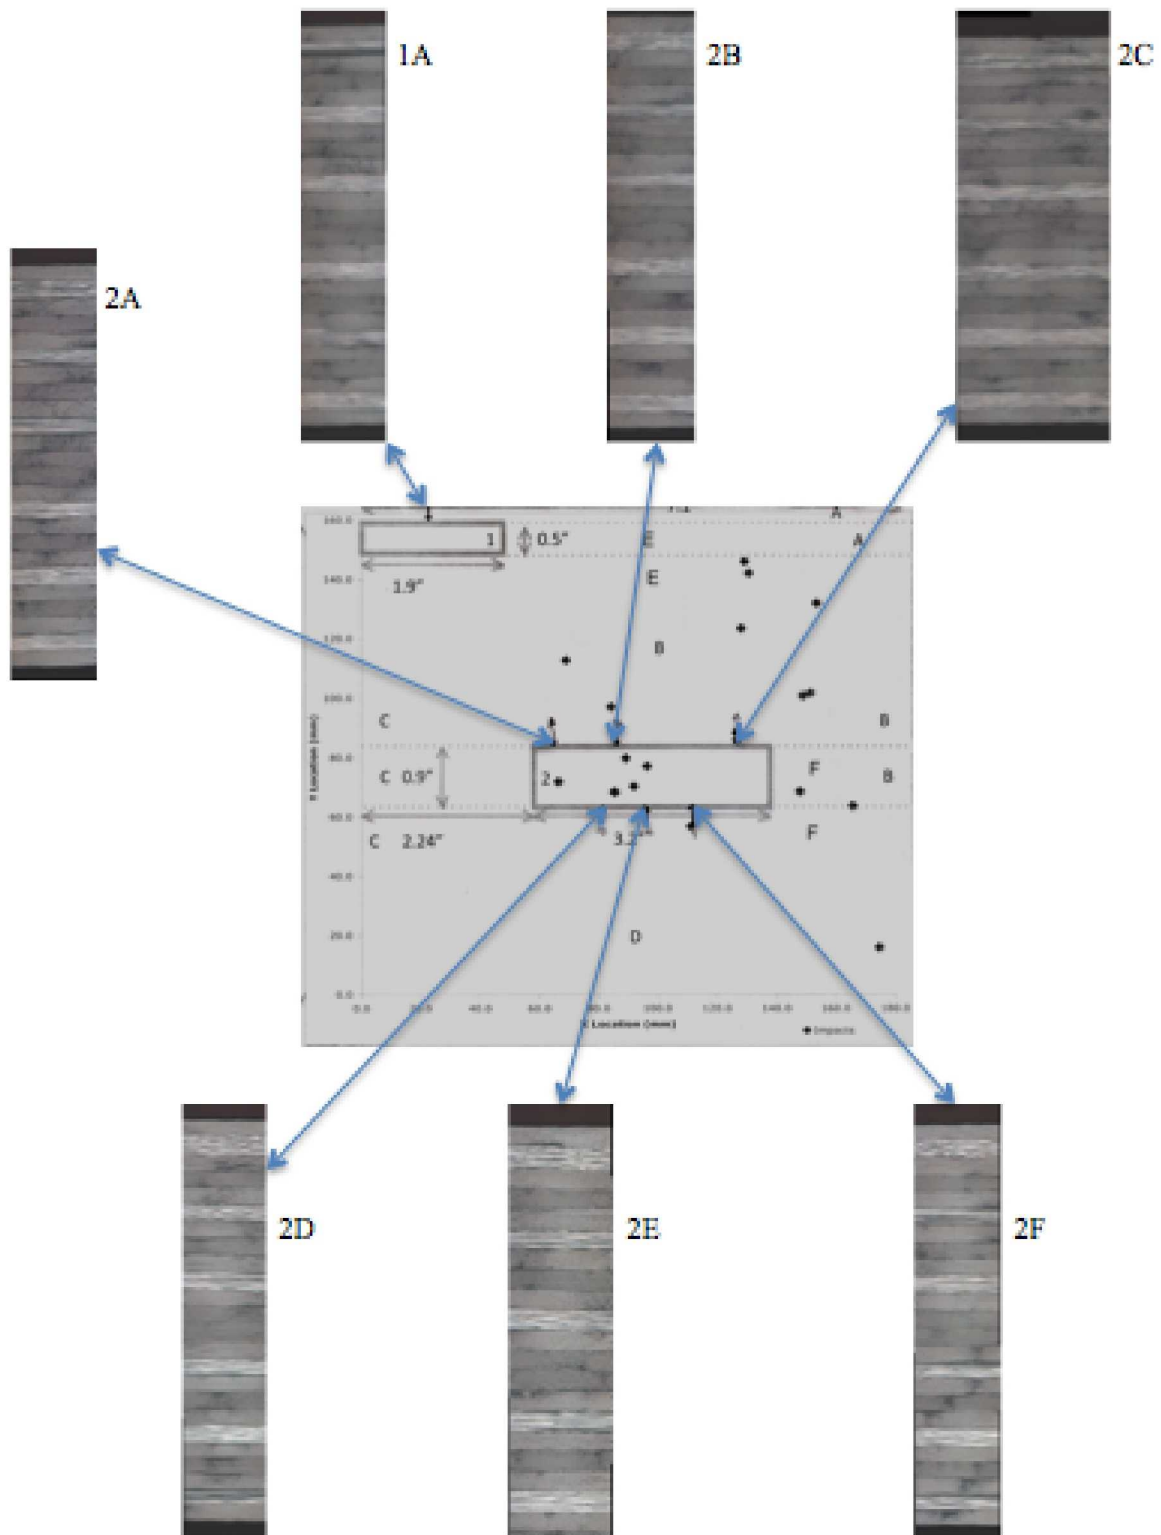
**Figure 17. Photomicrograph map of RT OLV FRPC test panel.**

Two specimens were cut and polished from the OLV RT FRPC test panel to assess the effects of the OLV impacts. The sections included areas with and without impacts and their respective location on the FRPC is shown in Fig. 17. Photomicrographs of these areas revealed no internal damage (i.e. delamination and microcracking) in all areas. This was further supported by the post-impact C-scan image shown in Fig. 15. These results are comparable to the SLG RT test results.

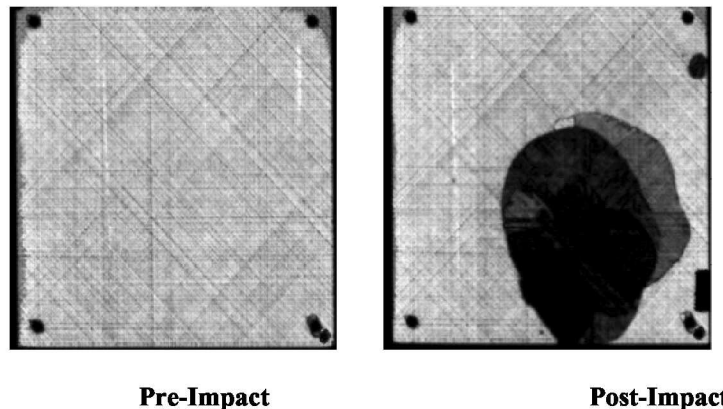
**Figure 19. C-scan of pre- and post-impact ET OLV panel.**

As observed for the post-impact C-scan image of the ET SLG HVI test panel (Fig. 5), the OLV ET post-impact C-scan image showed internal damage (Fig. 19). However, no surface deformations or cracks were apparent upon visual inspection under magnification.

Unlike the SLG ET test panel, this panel had been heated twice. The initial test resulted in the gun firing, but no particles were recorded reaching the target based on no flashes being recorded by the PMT and on the streak camera film. Additionally no impacts were found upon summary inspection of the test panel. Therefore it was concluded that the panel was “pristine” resulting in its being used for a retry of the ET test. As a note, the panel had not been ultrasonically inspected after this initial test to see if any internal damage could be observed. The second ET test was successful with the gun firing and data being recorded. The post-impact C-scan image of the panel revealed two different shadings in the impact area (Fig. 19). These two areas may be due to the two different heating events and not from the OLV impactors, or that the first test did provide impacts but with no recorded data. The exact cause is unknown. Further work must be performed to make an adequate determination to the cause of the internal damage observed in the post-HVI C-scan image.

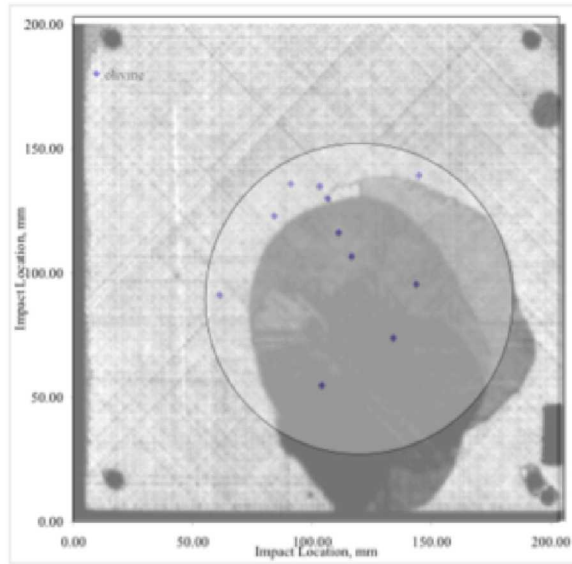
**Figure 21. Overlay of post-impact panel C-scan image over graphed OLV impacts.**

The relationship between the damage area and the impact locations was evaluated in the same manner as for the SLG ET test panel (Fig. 21). As seen in the overlay, approximately half of the impacts lie within the damage zone. The underlying damage is quite extensive and is greater than that observed for the SLG ET post-test panel. As mentioned this panel had been shot twice, raising the question of whether it was truly “pristine” since it had only been visually examined and not ultrasonically inspected prior to retesting.

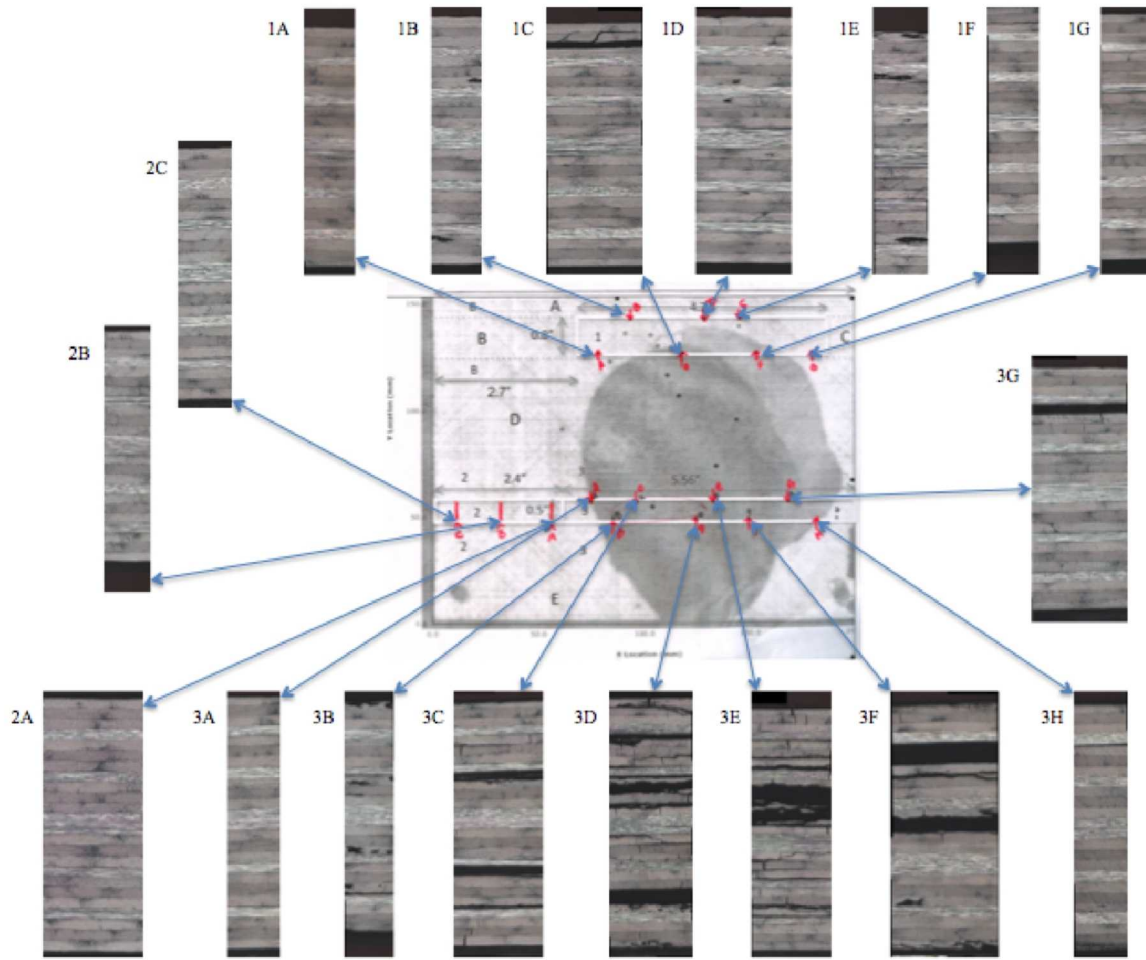
**Figure 22. Photomicrograph map of RT OLV FRPC test panel.**

To assess internal damage, three sections were cut from the post-impacted FRPC and photomicrographed. These sections included areas with and without impacts as well as areas within and outside the damage area indicated in the C-scan image. The photomicrographs of these areas and the associated location on the FRPC are shown in Fig. 22. Photomicrographs from section 2 revealed no evidence of damage as was expected since this area was outside of the damage zone and devoid of impacts. Similar results were observed for the areas shown by photomicrographs 1A and B, 1G, and 3A. Microcracks were observed in the top couple of plies for areas indicated by 1D and 1E. Delamination was observed in photomicrographs 1C and F and 3B and H for the peripheral area of the dark zones as indicated by the C-scan image. The remaining photomicrographs (i.e. 3C-G) were taken in areas within the primary dark area and revealed varying degrees of microcracking and delamination. Even though the OLV and SLG ET test panels were heated differently, the results appear to be comparable.

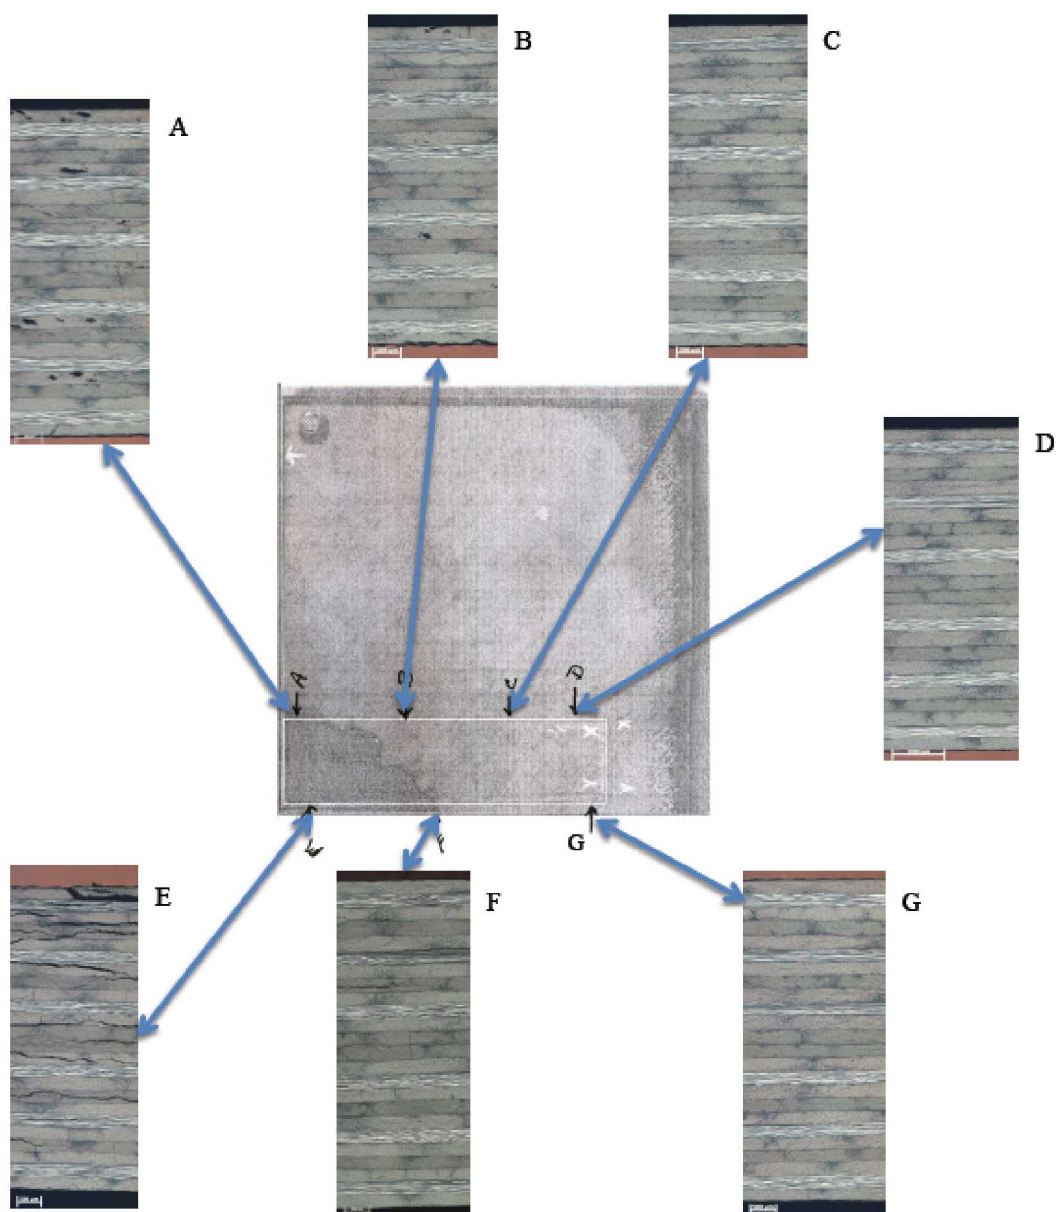
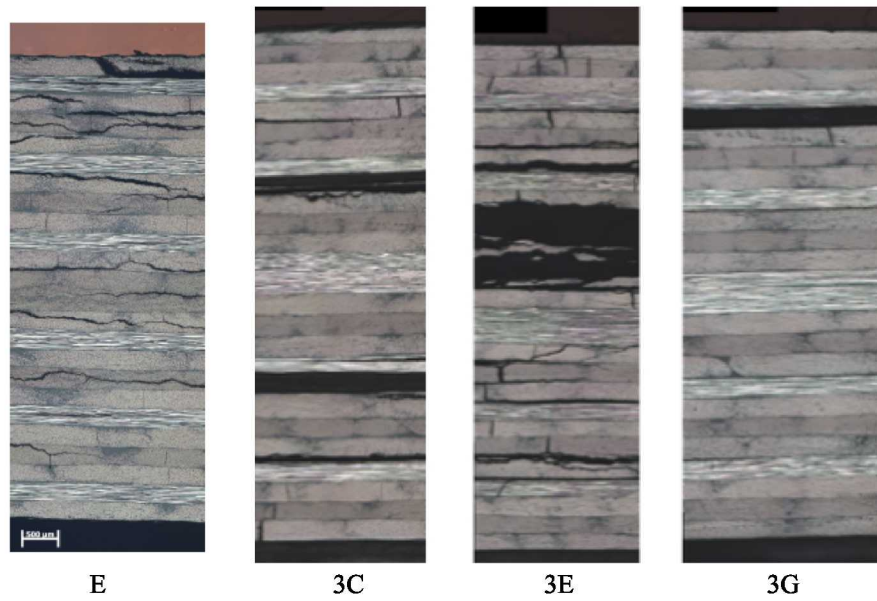
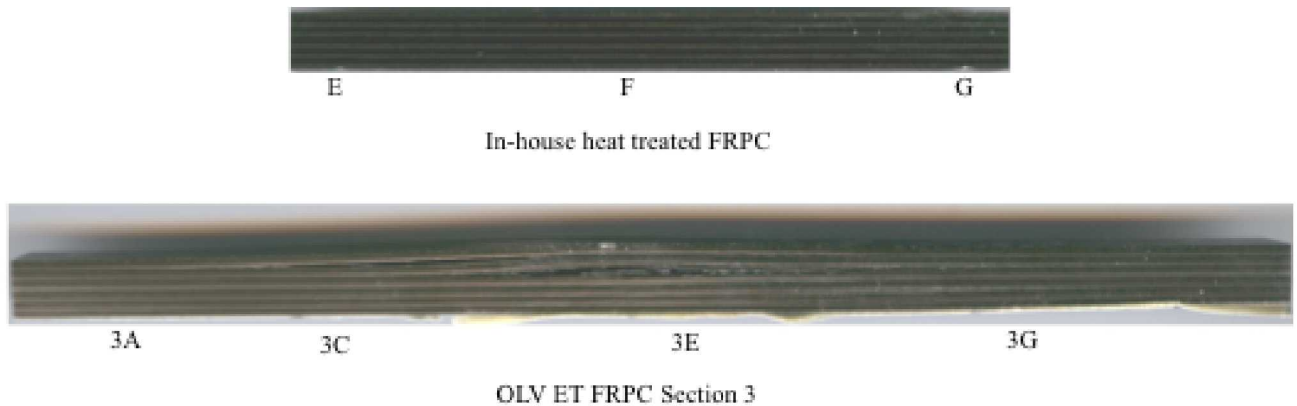
A qualitative heating trial was performed on a quasi-isotropic 10.16 cm x 10.16 cm panel to assess what kind of damage may be induced by heat alone. This panel was placed edgewise on a platen with a thermocouple attached to the opposing side of the region to be heated. The temperature was slowly raised until it reached 175°C and was maintained for an hour. During this hold the temperature ranged from 173 to 188°C. Once cooled to RT, warpage of the FRPC surface was observed upon placement on a flat surface. Additionally, there was noticeable discoloration of the area that was in contact with the heated platen surface. Ultrasonic examination of the post-heated panel revealed a delaminated area in this heated region that was not present in the pre-heated C-scan image. To assess the internal damage, a section was cut from this qualitative FRPC and photomicrographs obtained. The photomicrographs and the post-heated C-scan image were overlayed onto the FRPC image as shown in Fig. 24. The delaminated area in the C-scan image can be seen in the lower left-hand corner of the FRPC. Photomicrographs A and E in this area revealed delamination as well as microcracking with image E showing more extensive damage. Comparing image E of this panel with images 3C, 3F, and 3G of the OLV ET FRPC (Fig. 25), one can see that the latter images show that the delaminated area was much more pronounced and separated than in the former. Comparing visual scanned images of the qualitative FRPC and section 3 of the OLV ET FRPC (Fig. 26), the heated qualitative FRPC appears to be pristine in this region while that of the OLV ET FRPC was noticeably delaminated.

One observation from this qualitative heat test was that thermocouple placement on the FRPC had a large effect upon the measured temperature. As previously mentioned, it is known that FRPCs have poor thermal conductivity and thus an overshoot in the temperature could have occurred. Whether the internal damage (i.e. delamination and microcracking) was primarily due to heat alone or in combination with the HVI impactors is still open to discussion.
